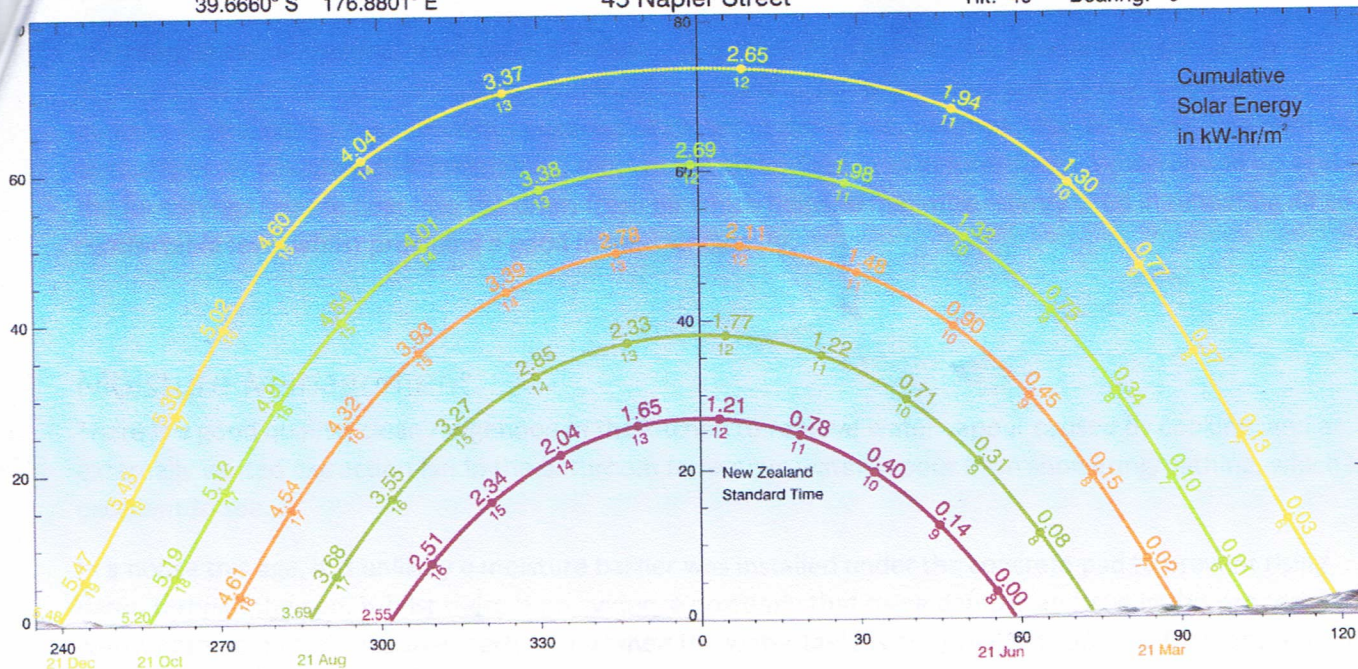
Figure 1 The solar gain profile for 45 Napier Street. This graphic shows the position of the sun at different times of the day at different times of the year.
